# CSB 99-6

## SUBJECT: GTSIO-520 & GIO-550 CRANKSHAFT INSPECTION

**PURPOSE:** To provide instructions for the inspection of the number two, five and eight crankshaft cheeks of GTSIO-520 style crankshafts manufactured or rebuilt in 1998.

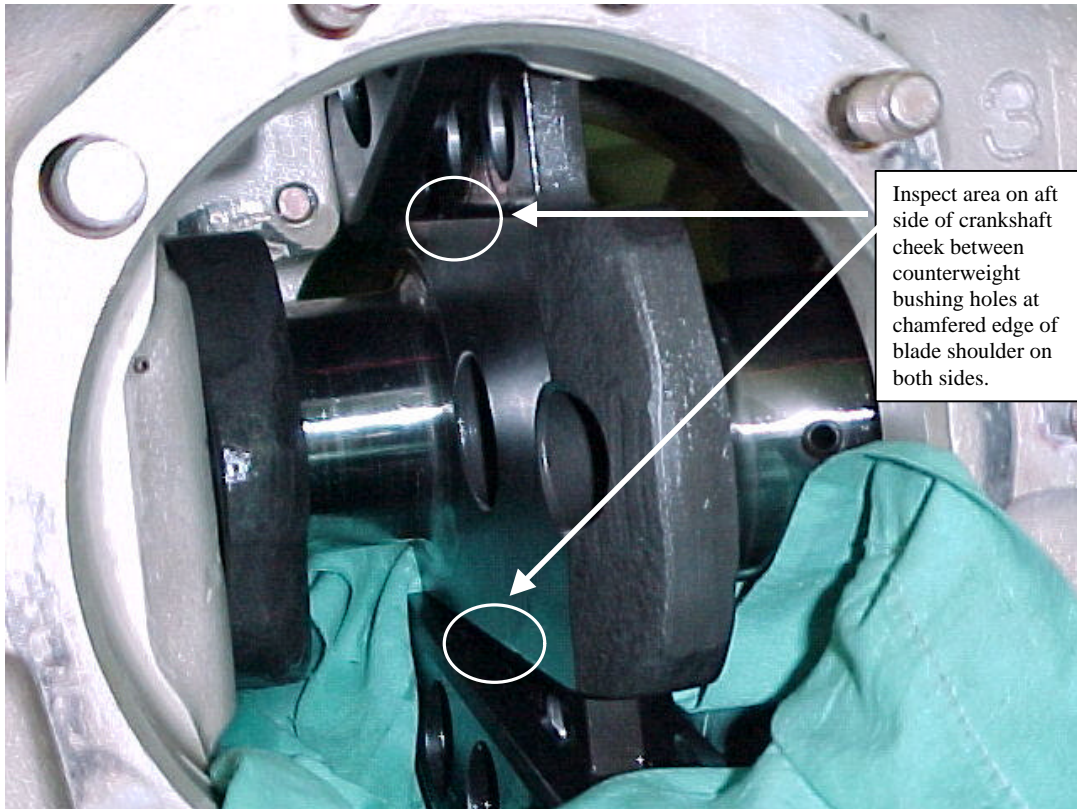
FIGURE 4  
 COUNTERWEIGHTS POSITIONED FOR VISUAL AND ULTRASONIC INSPECTION  
 (VISUALLY INSPECT CIRCLED AREA FOR CRACK INDICATIONS)

5. Using a flashlight and mirror or a borescope visually inspect the aft side of the number two crankshaft cheek for indications of a crack or mechanical damage. The inspection area is between the counterweight blade bushing holes at the chamfered edge of blade shoulder on both sides of the crankshaft cheek aft face. See Figure 4.

6. If visual inspection reveals a crack the engine must be removed from service until repaired or replaced.

7. If the visual inspection does not clearly reveal a crack, perform an ultrasonic inspection of the aft side of the number two crankshaft cheek in accordance with Section "B" ULTRASONIC INSPECTION.
8. Reinstall the number 2 crankshaft cheek counterweights and install the counterweight pins in their original location. Place masking tape over the counterweight pin holes before rotating the crankshaft to inspect the number 5 and 8 crankshaft cheeks.
9. Repeat steps 1 (one) through 8 (eight) for crankshaft cheeks five and eight.

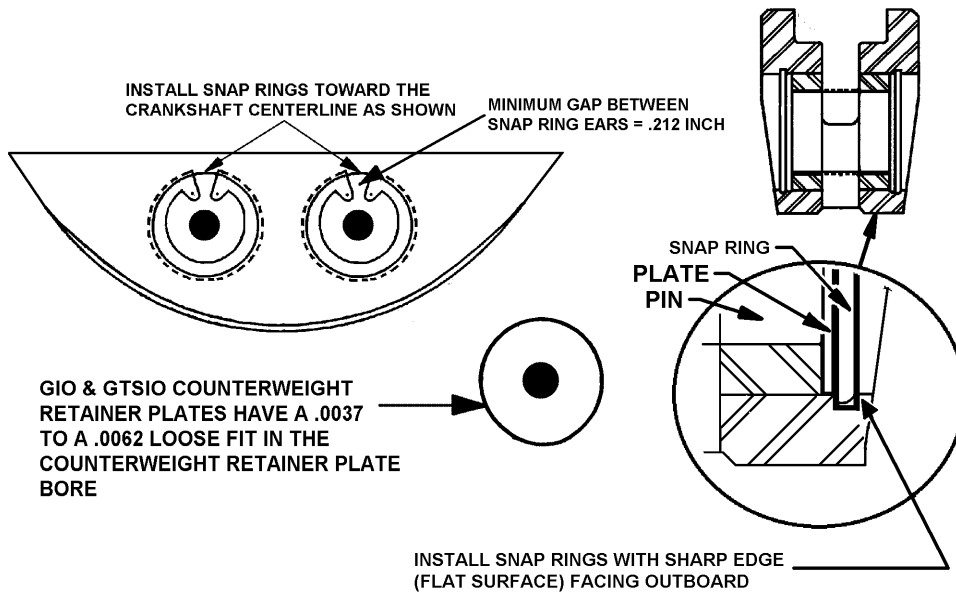
FIGURE 5

**Note:** Use an inspection mirror and flashlight to verify that the entire circumference of each snap ring is fully seated in the counterweight snap ring groove.

*The snap rings and retainer plates must be installed as shown in Figure 5.*

3. Visually and dimensionally inspect all snap rings to insure the snap ring is correctly installed and fully seated in its groove. See Figure 5.
4. Drain the engine oil into an approved container.
5. Apply 50-weight Aviation grade oil to the number one, three and five crankshaft connecting rod journals and bearing inserts.
6. Install the number one, three and five connecting rods, with bearing inserts in place, on their respective crankshaft connecting rod journal. Ensure that the connecting rod and cap position numbers match each other and are facing up when installed.
7. Lubricate the threads of the connecting rod bolts and nuts with clean 50-weight aviation grade oil and thread the nuts onto the bolts.
