TELEDYNE CONTINENTAL[®] AIRCRAFT ENGINE

SERVICE BULLETIN

SB01-5

SUBJECT: STARTER ADAPTER BEVEL GEAR INSPECTION

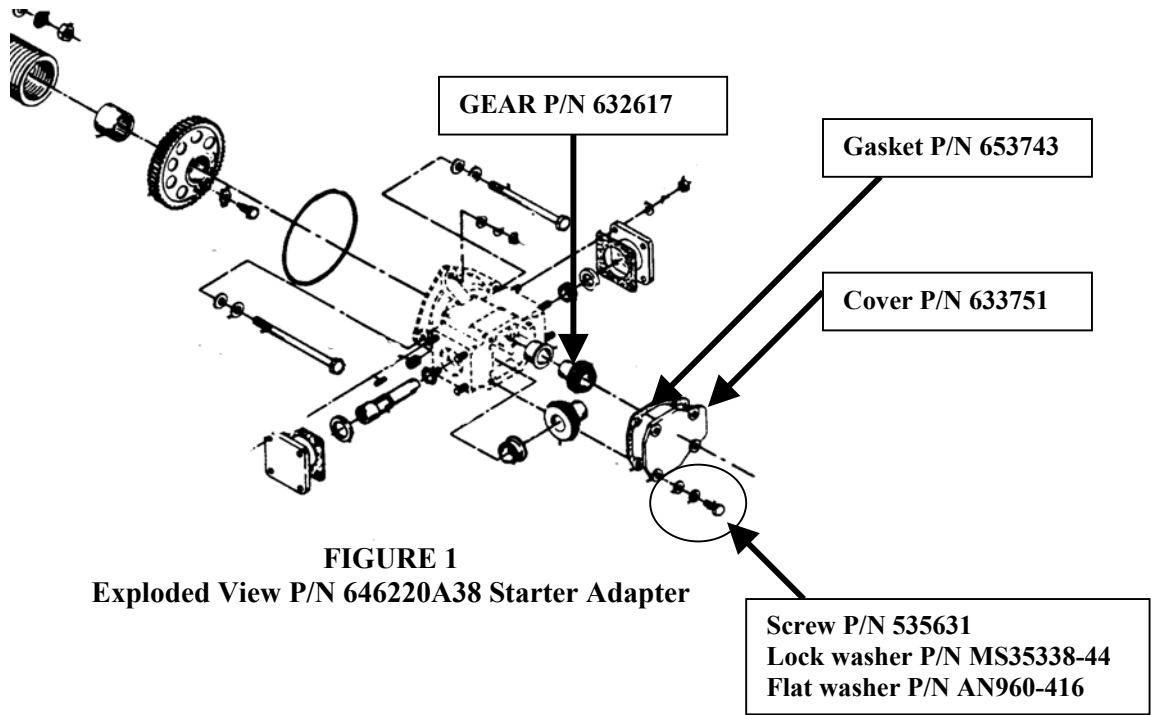
FIGURE 1
Exploded View P/N 646220A38 Starter Adapter

1. In accordance with the aircraft manufacturer's instruction gain access to the engine and specifically the engine accessory area.
2. Referring to Figure 1, remove the "T" drive cover plate P/N 633751, by removing 4 each screws, 4 each lock washers and 4 each flat washers. Remove gasket P/N 653743.
3. Visually inspect bevel gear P/N 632617 for indication of gear tooth distress, spalling, broken or chipped gear teeth. Inspect interior of "T" drive housing for gear debris.
4. If visual inspection DOES NOT reveal any damage to bevel gear P/N 632617 and there is no gear debris noted in "T" drive housing interior reinstall cover P/N 633751 using a new gasket P/N 653743 and new lock washers P/N MS35338-44. Torque screws P/N 535631 to 75 to 85 inch pounds.
On completion of the above inspection, complete the owner notification form and mail it or fax it to TCM. ①

5. If visual inspection reveals damage to bevel gear P/N 632617 or if there is debris in the interior of the "T" drive housing the starter adapter assembly will have to be removed for repair or replacement. Contact TCM Technical Service Support at 1-888-826-5465
