[Docket No. 97-CE-67-AD]

#### Airworthiness Directives; Cessna Aircraft Company 300 and 400 Series Airplanes

**ACTION:** Notice of proposed rulemaking (NPRM).

**SUMMARY:** This document proposes to supersede Airworthiness Directive (AD) 75-23-08 R5, which currently requires repetitively inspecting and replacing or repairing the exhaust system on certain Cessna Aircraft Company (Cessna) 300 and 400 series airplanes. The proposed AD would replace the inspections and replacements that are required by AD 75-23-08 R5 with inspections and replacements containing new simplified procedures for all 300 and 400 series airplanes (models affected by the current AD plus additional models). The proposed AD would also revise the inspection intervals and would require replacing certain unserviceable parts and removing the exhaust system for detailed inspections at regular intervals. The proposed AD is the result of numerous incidents and accidents relating to the exhaust systems on Cessna 300 and 400 series airplanes dating from the middle 1970's to the present, including six incidents since issuance of AD 75-23-08 R5 where exhaust problems were cited. The actions specified by the proposed AD a

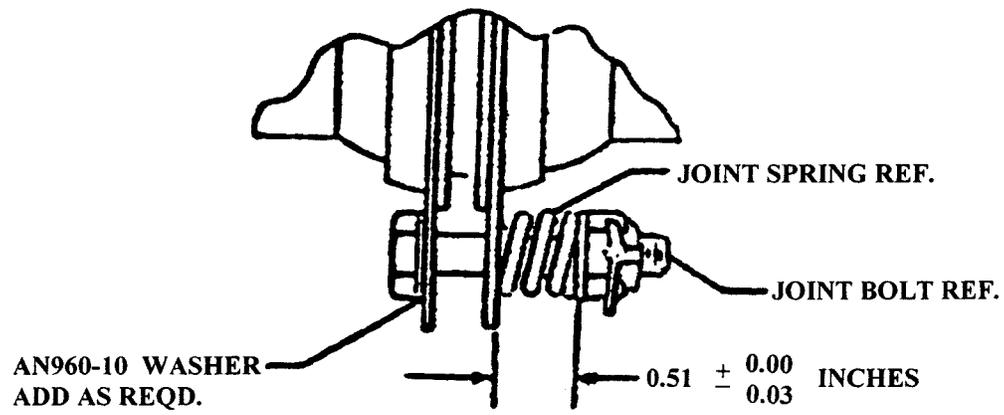
FIGURE 1 to the Appendix

(3) Visually inspect the exhaust joint springs for correct compression. If the joint is disturbed or if the springs are obviously loose or frozen, proceed with the following inspection (see Figure 1 of this Appendix).

(i) Before removal of the exhaust joint springs, measure the installed length of each spring, and replace the springs compressed to less than .45 inch.

(ii) Remove all the springs and measure the free length. Replace any spring having a free length of less than .57 inch.

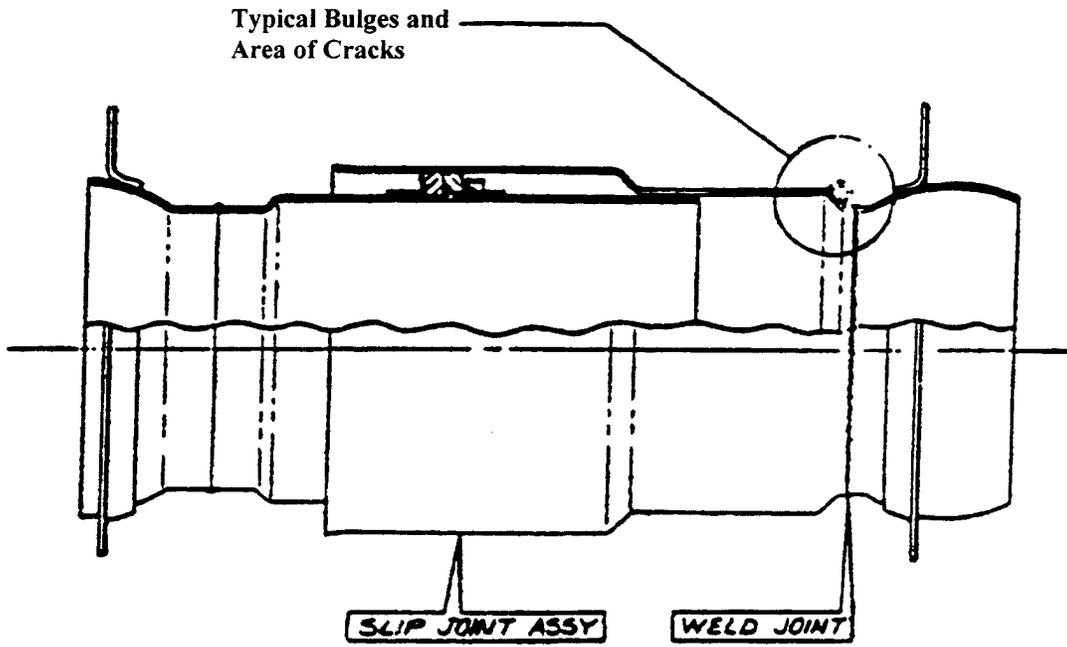
FIGURE 2 to the Appendix

(4) If installed, visually inspect the slip joint(s) for bulges beyond the normal manufacturing irregularities of .03 inches and/or cracks. If any bulges and/or cracks are present, replace the bulged or cracked slip joint(s). (Refer to the appropriate Cessna Aircraft Service Manual) (See Figure 2 of this Appendix).

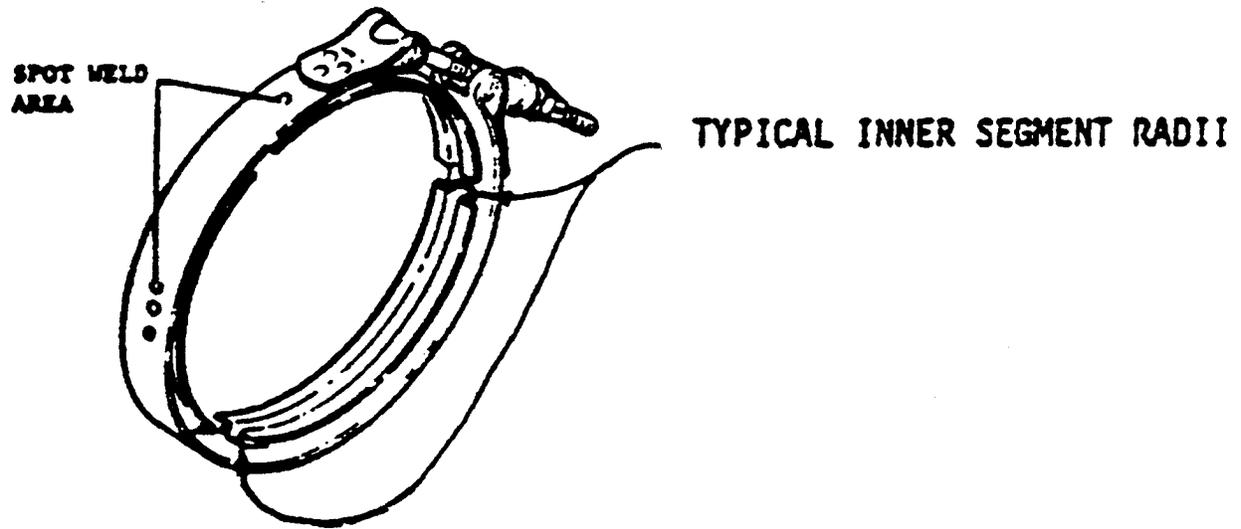
FIGURE 3 to the Appendix

(i) Visually inspect the outer band in the area of the spot weld for cracks (see Figure 3 of this Appendix). If cracks are found, replace the clamp(s) with new multi-segment "V" band clamp(s).

(ii) Visually inspect the corner radii of the clamp inner segments for cracks (see Figure 3 of this Appendix). This inspection requires careful use of artificial light and inspection mirrors.

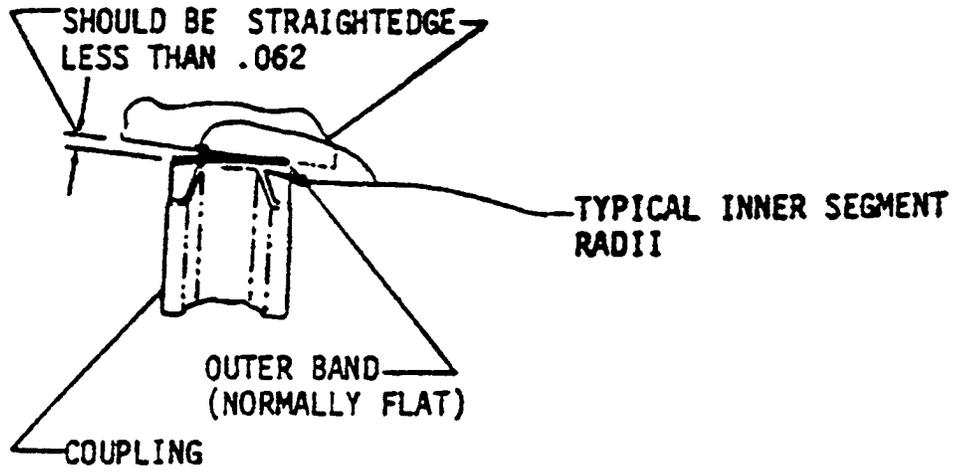
FIGURE 4 to the Appendix

than 0.062 inch. If deformation exceeds the 0.062-inch limit, replace the clamp(s) with new multi-segment clamp(s). (See Figure 3 of this Appendix). See Cessna maintenance manual(s) and revisions for correct installation procedures.

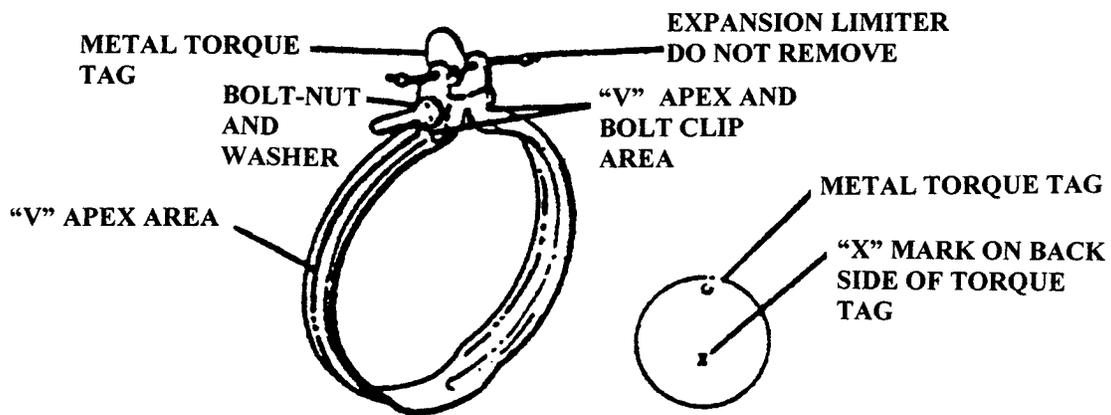
FIGURE 5 to the Appendix

(iv) Visually inspect the one-piece "V" band clamp (overboard exhaust to turbocharger) with a light and mirror, in the area of the clamp surfaces adjacent to the intersection of the "V" apex and bolt clips, and the entire length of the "V" apex of the clamp for signs of cracks or fractures. If cracks or fractures are visible, replace the clamp (see Figure 5 of this Appendix). See Cessna service manual(s) and revisions for correct installation procedures
