National Transportation Safety Board

Safety Recommendation

Date: July 1, 2013

In reply refer to: A-13-024

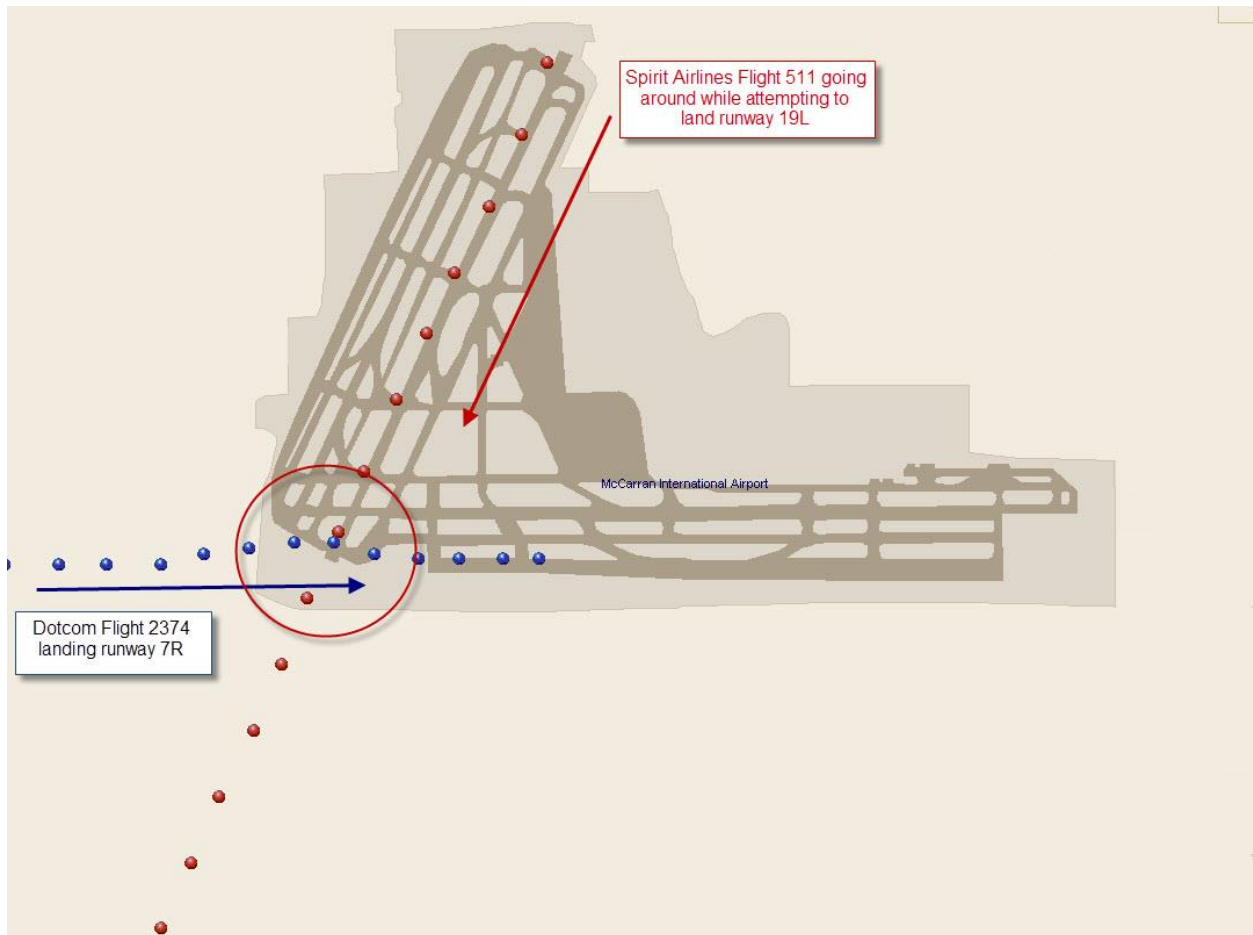
On July 30, 2012, about 1944 coordinated universal time (UTC), two airplanes came within hazardous proximity of one another at Las Vegas-McCarran International Airport (LAS), Las Vegas, Nevada,² when Spirit Airlines flight 511, an Airbus Industries A319, was executing a go-around from runway 19L and Dotcom flight 2374, a Cessna Citation 510, was landing on runway 7R (see figure 2). Runways 19 L/R and 7L intersect and may not be operated independently of one another. Runway 7R is located approximately 1,000 feet south of runway 7L and does not intersect any other landing surface, permitting controllers to conduct arrival and departure operations independently of all other runways; however, the flightpath of runway 19L intersects the flightpath of runway 7R. The airplanes were being controlled by separate LAS ATC tower controllers operating on different frequencies. The pilot of Spirit Airlines flight 511 announced that the airplane was “on the go,” and the air traffic controller immediately responded with “traffic ahead and to your right landing 7R is a Citation out of 2600 off your right.” The transmission was not acknowledged, and the controller

instructed Spirit Airlines flight 511 to “expedite your climb.” The pilot of Spirit Airlines flight 511 never reported Dotcom flight 2374 in sight.

When the controller responsible for Dotcom flight 2374 recognized that Spirit Airlines flight 511 was executing a go-around, he notified the Dotcom flight 2374 pilot of the position of Spirit Airlines flight 511 but did not provide any control instructions to ensure that the airplanes avoided one another. According to recorded radar data, the pilot of Dotcom flight 2374 turned the airplane off of the final approach course to the left to pass behind Spirit Airlines flight 511, then turned back to the runway and landed on runway 7R. Spirit Airlines flight 511 passed in front of and slightly above Dotcom flight 2374 on short final. The reported closest proximity was 0.21 nautical miles (nm) laterally and 100 feet vertically. There were no injuries reported to passengers or flight crew and no damage reported to either airplane.

Figure 2. Spirit Airlines flight 511 (red dots) executed a go-around while attempting to land on runway 19L. Dotcom flight 2374 (blue dots) was simultaneously landing on runway 7R.

Amend Federal Aviation Administration Order 7110.65, "Air Traffic Control," to establish separation standards similar to the provisions of paragraph 3-9-8 between an arriving aircraft that goes around and any combination of arriving or departing aircraft operating on runways where flightpaths may intersect. (A-13-024)

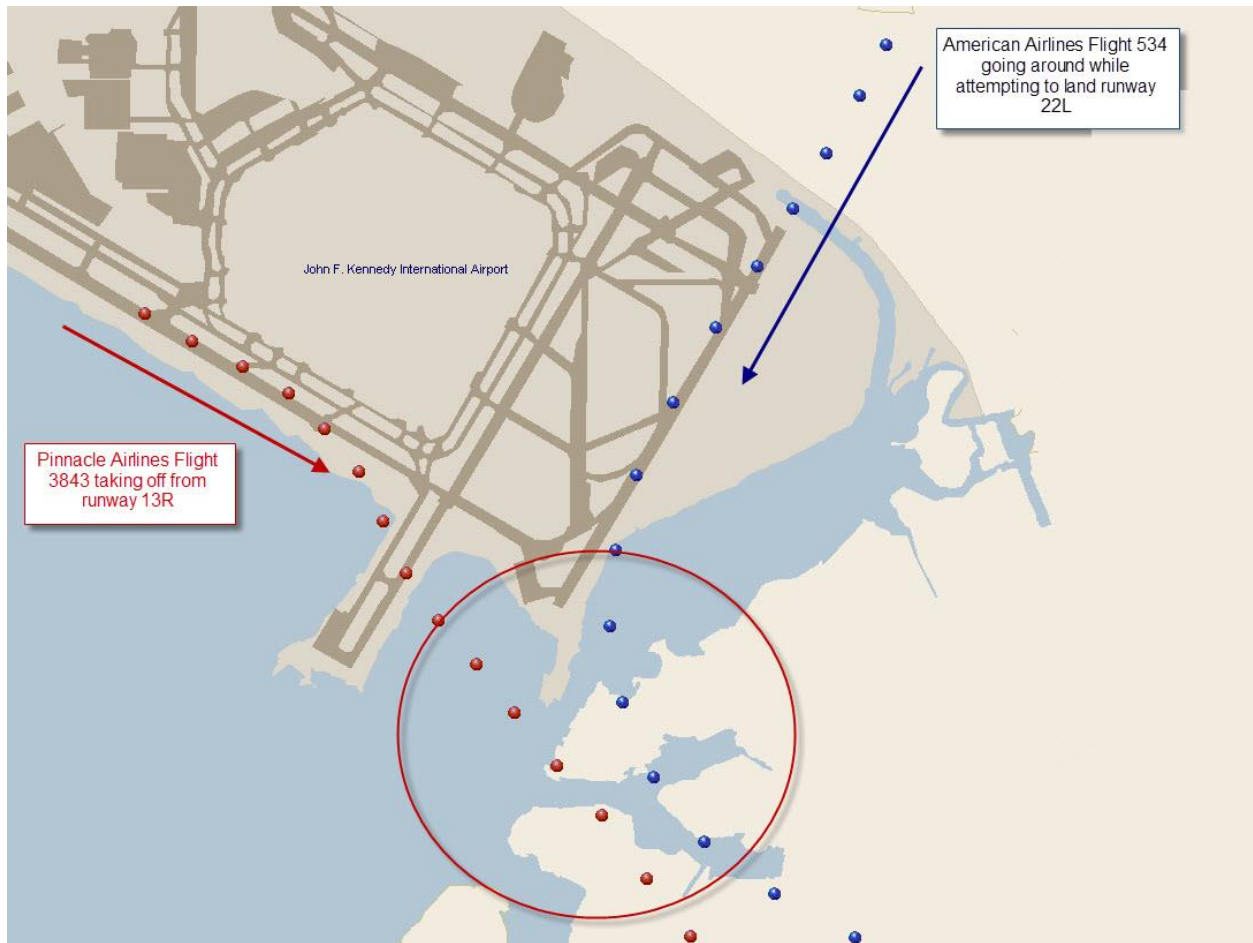
On July 30, 2012, about 2004 UTC, two airplanes came within hazardous proximity of one another at John F. Kennedy International Airport (JFK), Jamaica, New York, when American Airlines flight 534, a Boeing 737, was executing a go-around while attempting to land

on runway 22L and Pinnacle Airlines flight 3843, a Bombardier CRJ 200 regional jet (RJ), was departing from runway 13R (see figure 3). Runway 13R does not intersect runway 22L; however, the flightpath of runway 13R intersects runway 22L. The airplanes were being controlled by separate JFK ATC tower controllers operating on different frequencies. When the pilot of American Airlines flight 534 notified ATC of the go-around, the controller instructed the pilot to “climb and maintain 2000 feet, traffic off to your left is an RJ turning southbound, turn left immediately heading 130.” The pilot responded and began the maneuver. The controller asked the pilot of American Airlines flight 534 if Pinnacle Airlines flight 3843 was in sight, and the pilot responded “We’re turning as tightly as we can.” When the controller asked the pilot of American Airlines flight 534 about the assigned altitude of 2,000 feet, the pilot responded “Negative, we are trying not to hit this aircraft off our right.” The controller responsible for Pinnacle Airlines flight 3843 had transferred communications to New York Departure Control and was no longer able to provide the pilot with control instructions or traffic advisories. American Airlines flight 534 returned for landing, and Pinnacle Airlines flight 3843 continued to its destination. There were no injuries reported to passengers or flight crew and no damage reported to either airplane.

Because of previous conflicts similar to the situation involving American Airlines flight 534 and Pinnacle Airlines flight 3843, JFK had been the subject of an FAA review of the runway configuration by the FAA Flight Standards Office, AFS-450, in 2009 that resulted in the establishment of an arrival/departure window (ADW) on the runway 22L final approach course. The ADW is an imaginary box including the area between 1 and 3 nm from the runway threshold. The intent of the ADW was to prevent conflicts between runway 13R departures and runway 22L arrivals by requiring the departure aircraft from runway 13R to be rolling for takeoff before the runway 22L arrival aircraft entered the ADW. Pinnacle Airlines flight 3843 was cleared for takeoff when American Airlines flight 534 was about 3.7 nm away from the runway 22L threshold. However, Pinnacle Airlines flight 3843 did not begin the takeoff roll until American Airlines flight 534 was inside the ADW. Consequently, the separation intended to be ensured through use of the ADW procedures was not ensured. Under the circumstances, the tower controller should have canceled the takeoff clearance for Pinnacle Airlines flight 3843 but did not do so. The two airplanes came within 0.3 nm laterally and 300 feet vertically following the evasive maneuvers by American Airlines flight 534.

Figure 3. American Airlines flight 534 (blue dots) executed a go-around while attempting to land on runway 22L. Pinnacle Airlines flight 3843 (red dots) was simultaneously cleared for takeoff from runway 13R.

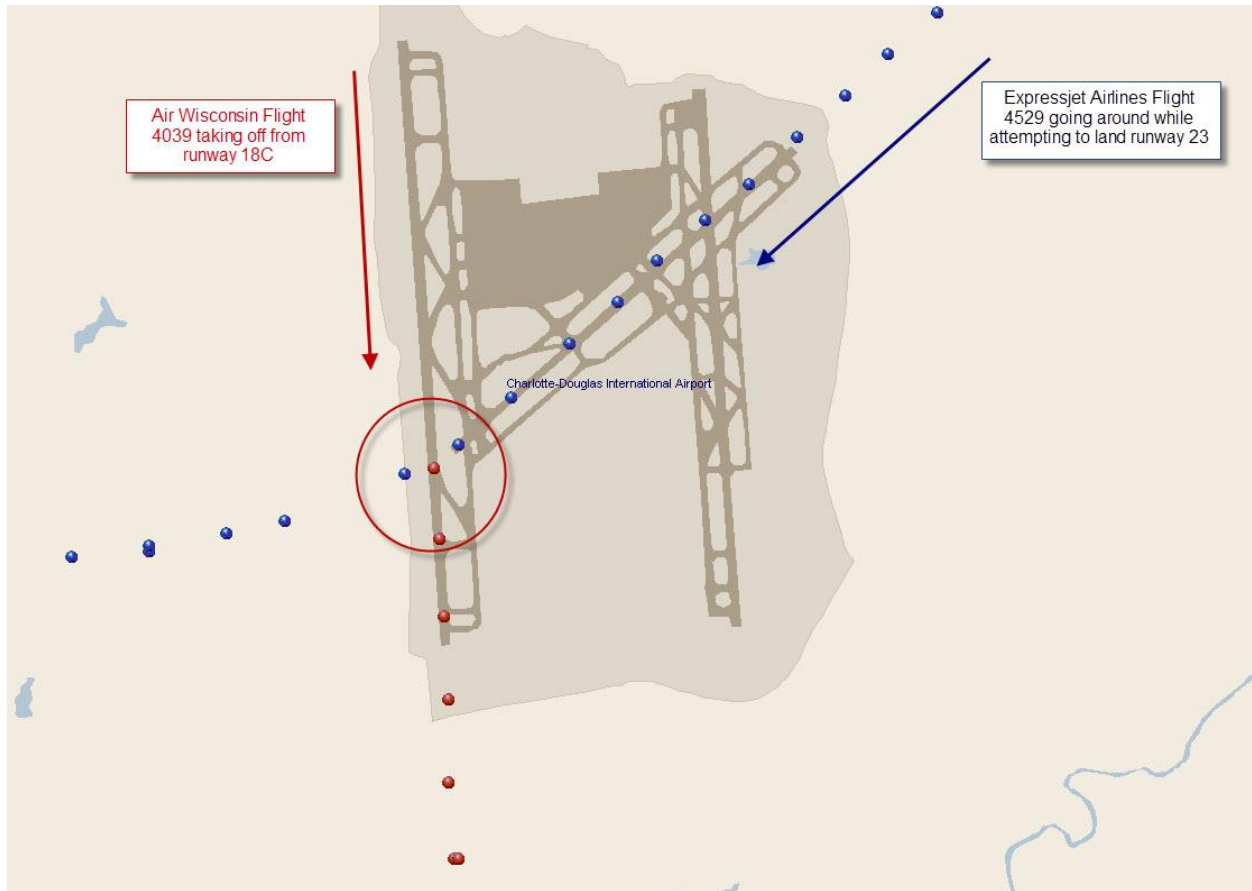
On July 14, 2012, about 1544 UTC, two airplanes came within hazardous proximity of one another at Charlotte International Airport (CLT), Charlotte, North Carolina, when Expressjet flight 4529, an Embraer 145 RJ, was executing a go-around while attempting to land on runway 23 and Air Wisconsin flight 4039, a Canadair RJ, was simultaneously departing from runway 18C (see figure 4). Runway 18C does not intersect runway 23; however, the flightpath of runway 23 intersects runway 18C. The airplanes were being controlled by separate CLT ATC tower controllers operating on different frequencies. When the pilot of Expressjet flight 4529 indicated that he was going around, the air traffic controller instructed the pilot to “Fly heading 270, climb and maintain 4000, traffic departing runway 18C beneath you.” The pilot of Expressjet flight 4529 did not confirm the transmission and never reported the conflicting departure in sight. The controller handling Air Wisconsin flight 4039 provided the pilot with a traffic advisory about Expressjet flight 4529 but issued no control instructions to resolve the conflict. The two airplanes passed within 0.16 nm laterally and 400 feet vertically of each other as Expressjet flight 4529 approached runway 18C. Expressjet flight 4529 returned for landing,

and Air Wisconsin flight 4039 continued to its destination. There were no injuries reported to passengers or flight crew and no damage reported to either airplane.

Figure 4. Expressjet flight 4529 (blue dots) executed a go-around while attempting to land on runway 23. Air Wisconsin flight 4039 (red dots) was simultaneously cleared for takeoff from runway 18C.

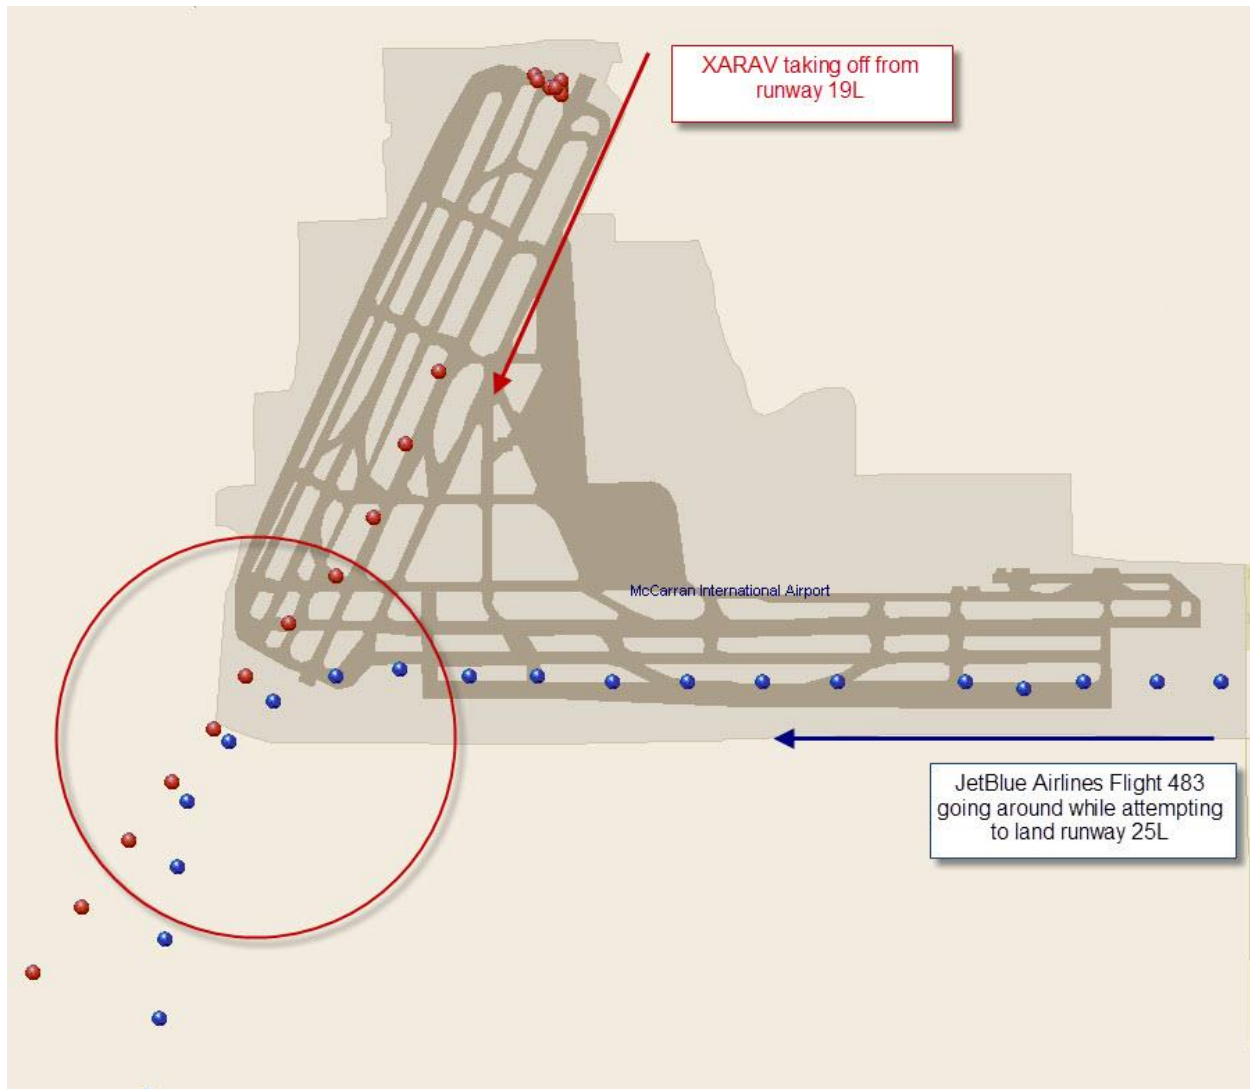
On April 26, 2012, about 1825 UTC, two airplanes came within hazardous proximity of one another at LAS when Jet Blue flight 483, an Airbus Industries A320, executed a go-around while attempting to land on runway 25L and XARAV, a Mexican-registered Bombardier Learjet 60, was departing from runway 19L (see figure 5).³ Runway 19L does not intersect runway 25L; however, the flightpath of runway 19L intersects the flightpath of runway 25L. Both pilots were communicating with separate LAS ATC controllers operating on different frequencies. During the go-around, Jet Blue flight 483 turned left to avoid XARAV. The pilot of XARAV saw Jet Blue flight 483 approaching from his left and initiated a rapid climb in an attempt to establish and maintain vertical separation. Review of recorded radar data for XARAV showed that the airplane's climb rate was as high as 6,000 feet per minute immediately after

departure. In radio transmissions from the pilot, the airplane's stick shaker⁴ can be heard in the background, warning the pilot of an imminent aerodynamic stall. The only separation instruction that ATC issued to XARAV was for the pilot to "go low," but by the time the instruction was issued, the airplane was climbing at a high rate and the pilot was unable to comply. The two airplanes' closest proximity was 0.30 nm laterally and 100 feet vertically. There were no injuries reported to passengers or flight crew and no damage reported to either airplane.

Figure 5. Jet Blue flight 483 (blue dots) executed a go-around from runway 25L. XARAV (red dots) was simultaneously departing from runway 19L.

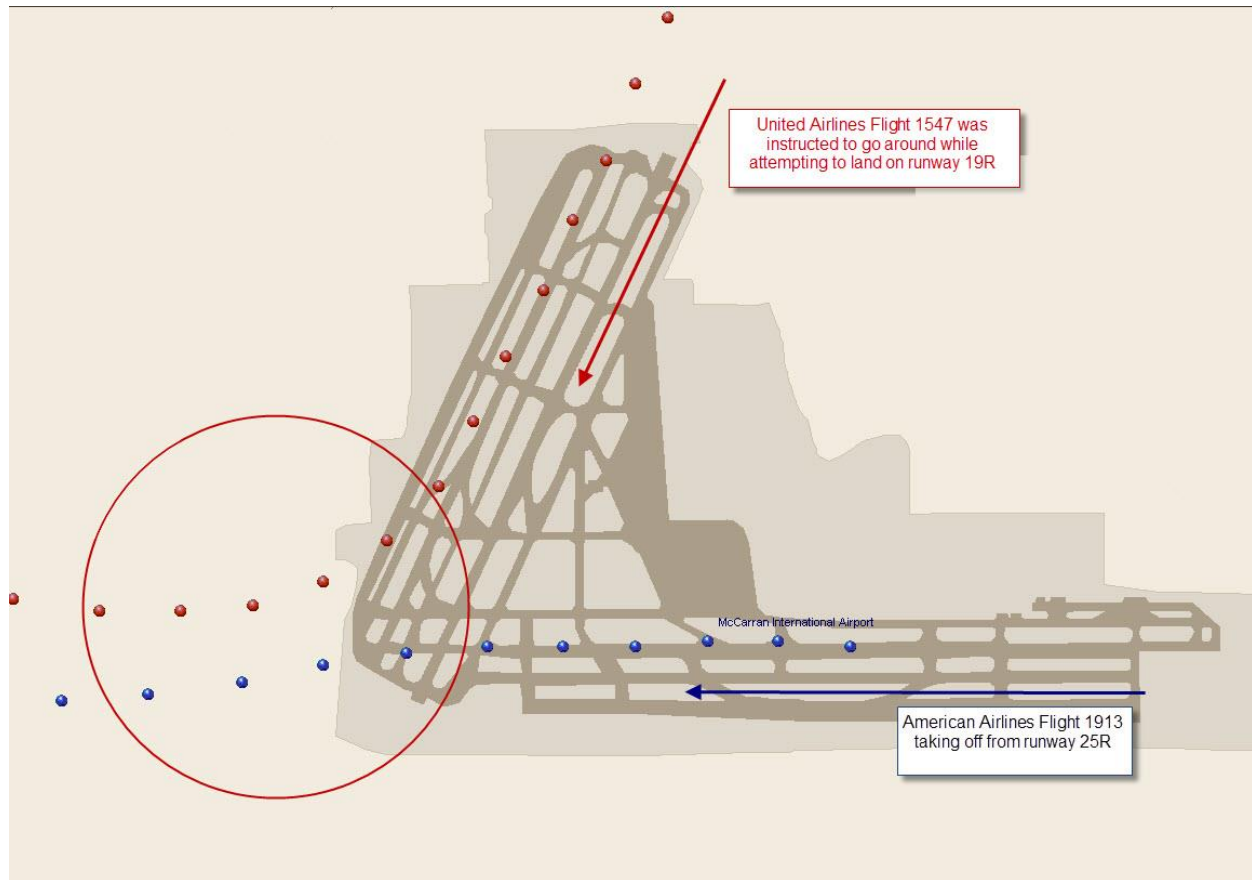
On January 27, 2006, about 0044 UTC, a near mid-air collision occurred at LAS when United Airlines flight 1547, an Airbus Industries A320, was attempting to land on runway 19R

but was instructed to go around by ATC to prevent a conflict with a Beechcraft BE200 crossing the runway. During the go-around, United Airlines flight 1547 nearly collided with American Airlines flight 1913, a Boeing 757 that was departing from runway 25R (see figure 6).⁵ Runway 19L did not intersect runway 25R; however, the flightpath of runway 19L intersected the flightpath of runway 25R. Both airplanes were in communication with separate LAS ATC tower controllers operating on different frequencies. When the controller handling United Airlines flight 1547 became aware of the conflict, he issued a safety alert to the pilot about the conflicting departure and instructed the pilot to "...turn at your discretion." During a postincident interview, the controller stated that he did not issue a specific direction to turn because wake turbulence separation rules did not permit him to have the Airbus A320 turn left immediately behind the departing Boeing 757, and a right turn might have been too slow as well as rendering the United Airlines flight 1547 flight crew unable to see the conflicting departure. The controller stated that he "...wanted the pilot-in-command to decide what to do." United Airlines flight 1547 made an evasive turn to the right to avoid a potential collision, reportedly banking as much as 40 degrees to avoid crossing American Airlines flight 1913's flightpath. American Airlines flight 1913 made a slight left turn and was instructed by the controller to "stay low." United Airlines flight 1547 returned for landing, and American Airlines flight 1913 continued to its destination. There were no injuries reported to passengers or flight crew and no damage reported to either airplane. In postincident statements, the United Airlines flight 1547 flight crewmembers stated that the tower controllers did not seem to have clear procedures for separating aircraft in the event of a go-around and may not have had the same perception of an impending collision that they did.

Figure 6. United Airlines flight 1547 (red dots) executed a go-around while attempting to land on runway 19R. American Airlines flight 1913 (blue dots) was simultaneously cleared for takeoff from runway 25R.
