## **SPECIAL AIRWORTHINESS INFORMATION BULLETIN**

**SUBJ:** POWERPLANT - ENGINE MOUNT – Cracking at nose landing gear attachment and trunnion attachment      **SAIB:** CE-09-13R1  
**Date:** July 14, 2014

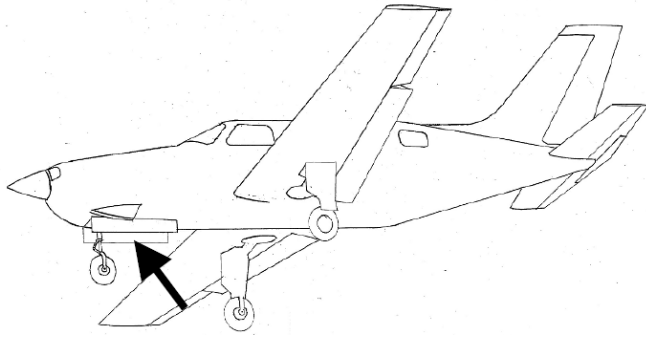
This SAIB is a result of reported cracks being found in the engine mount, both where the actuator for the nose landing gear attaches and at the pivot where the NLG trunnion attaches. Figures 1a and 1b below show the general area.

Figure 1a. General location of engine mount

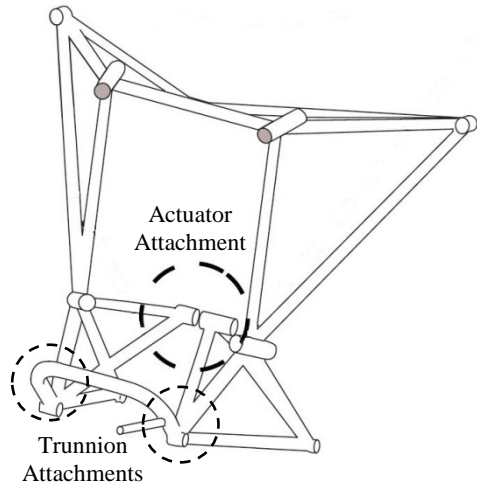
Figure 1b. Typical engine mount crack locations

After reviewing the above data, we recommend that you inspect the engine mount where the nose landing gear trunnion and actuator attach. We also recommend that you replace the mount with a new mount that relieves the repetitive inspection, where applicable. You should perform the inspection and replacement following the appropriate Piper service information SL 1001, SB 1103, and/or SB 1154 for the model and serial number of your aircraft and the configuration of your engine mount.

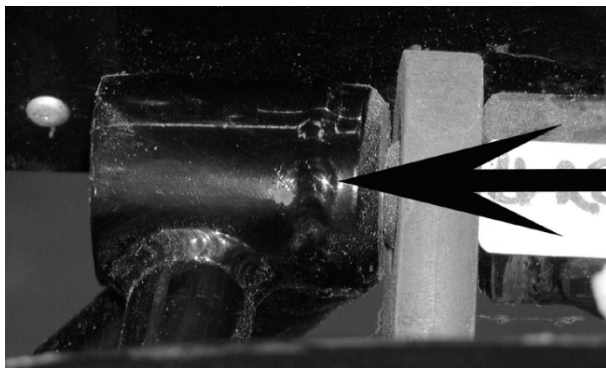
The first type, and the subject of SB 1103, is cracking around the circumference of the “foot” (the metal tube where the actuator bolt attaches). The “foot” cracks occur on some early engine mounts where the “foot” is made up of two parts; a metal disk welded to a metal tube. The cracks have been found in the welded area between the disk and tube. Some aircraft have a one-piece machined foot and have not experienced this problem. See Figures 2a and 2b below (from SB 1103C) showing pictures of both welded and machined configurations.

Figure 2a. Original Engine Mount Weld Indicates Two (2) Piece Foot

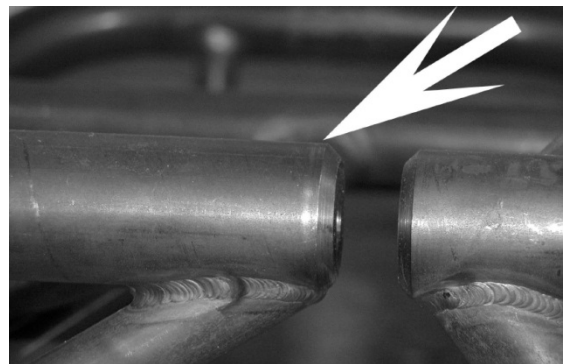
Figure 2b. Interim redesign Engine Mount One (1) Piece Machined Foot

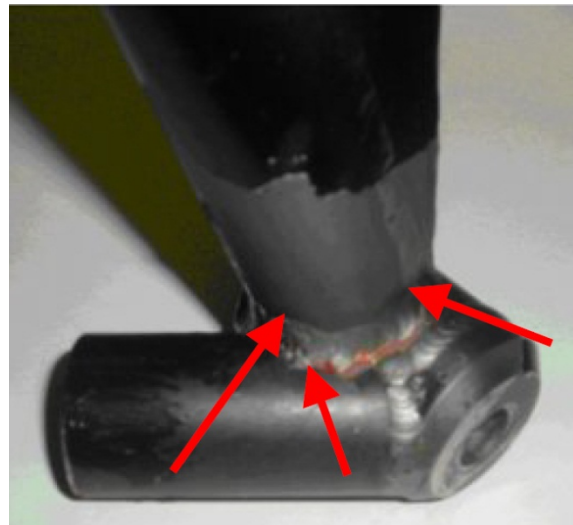
The second type of cracking is in the actuator cluster weld, which attaches the “foot” to the engine mount tubing, and is the subject of service bulletins 1103 and 1154. This second type of cracking occurs in the welded joints where the foot attaches to the engine mount tubes (cluster weld). See Figure 3 below. This type of cracking is independent of whether the foot is welded or machined.

Figure 3. Cracks around Tube Cluster  
(Note: crack extends into tube)
