# SINGLE ENGINE CUSTOMER CARE SERVICE INFORMATION LETTER

SE80-3

SUBJECT: DOOR POST MAPLIGHT SWITCH INSULATOR

AIRCRAFT APPLICABILITY: 1977 and on Model 172 and R172  
1975 and on FR172  
(See Remarks for specific serials)

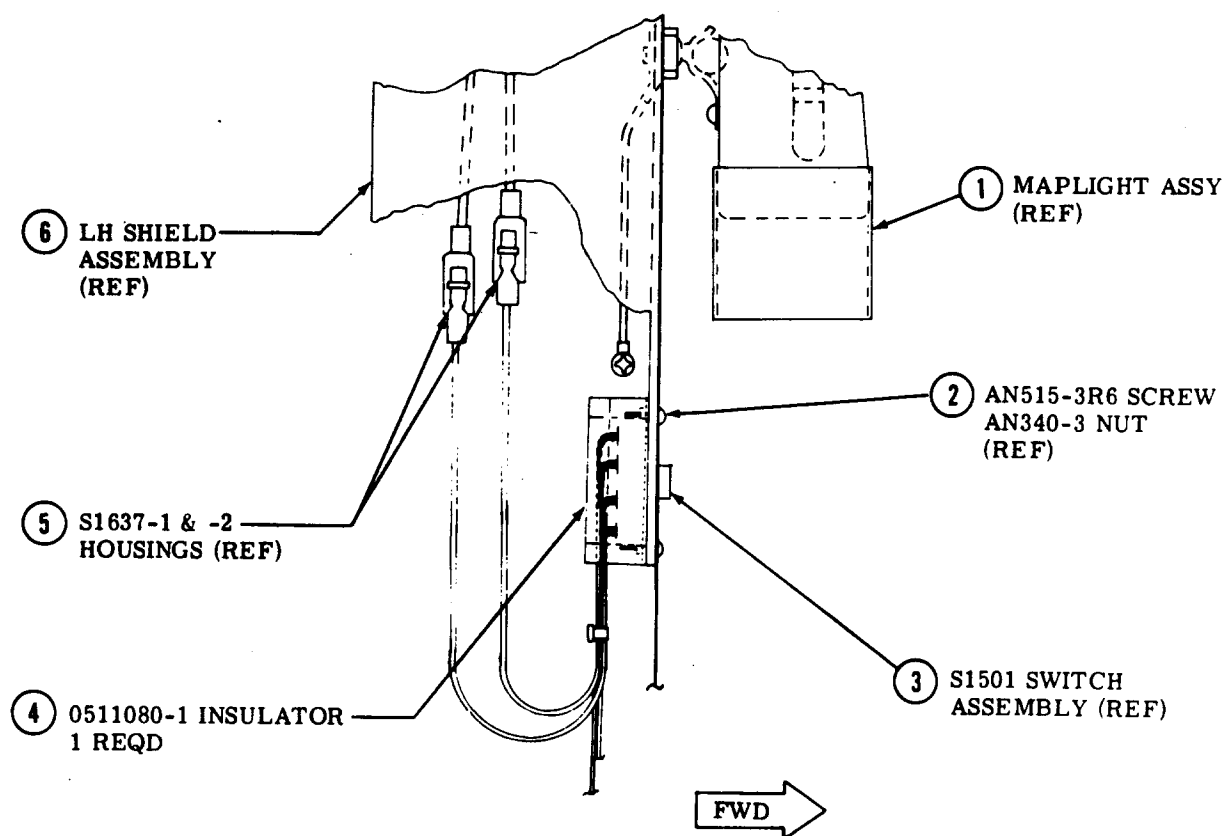
VIEW LOOKING OUTBD AT LH  
FWD DOORPOST

#### INSTALLATION OF SWITCH INSULATOR - DOORPOST MOUNTED MAPLIGHT

Be sure Master Switch is in "OFF" position before starting modification.

1. Remove shield assembly (6) from doorpost far enough to gain access to switch assembly (3).
2. Loosen screws and nuts (2) enough to slip the slotted ends of the insulator (4) under the switch assembly (3), between the switch and shield assembly.
3. Secure switch assembly (3) and insulator (4) to shield assembly (6) with screws and nuts (2).
4. Reinstall shield assembly and check maplight for proper operation.
