Service Bulletin

SEB00-1

DOORPOST MAPLIGHT SWITCH INSULATOR INSPECTION

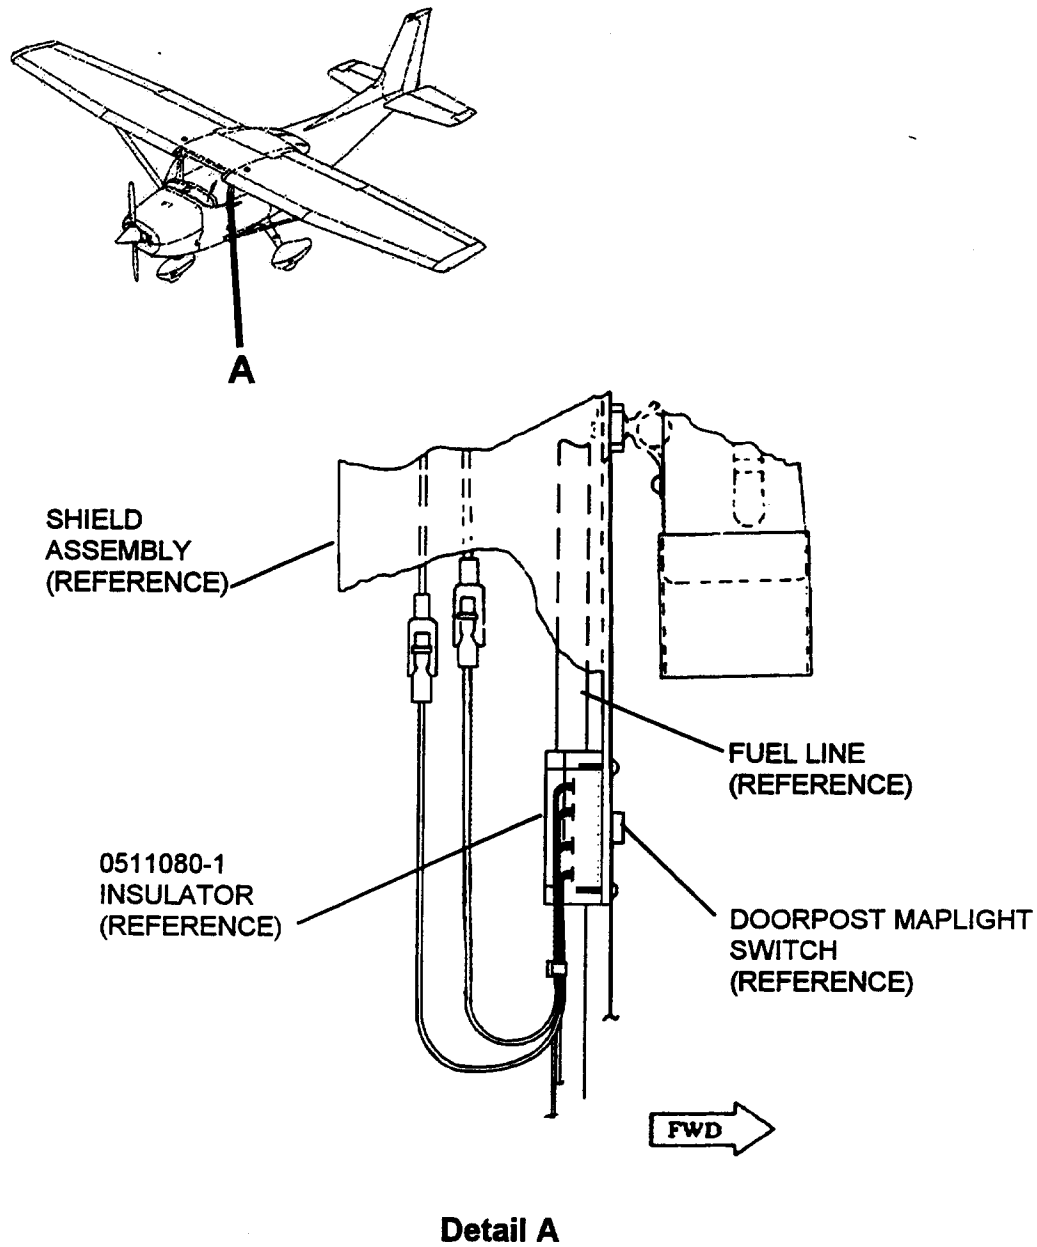
Figure 1. Doorpost Maplight Switch Insulator
Inspection

To inspect the maplight switch mounted in the left forward doorpost for the presence and condition of the protective switch cover. Non-compliance with this service bulletin could allow interference to occur between the maplight switch and the fuel line in the doorpost area. This condition, if not corrected may result in chaffing of the fuel line which could cause a leak and potential fire.

1. Inspect Doorpost Maplight Switch Insulator.
 - A. (Refer to Figure 1.) Remove Shield Assembly from left forward doorpost far enough to gain access to switch assembly.

- B. (Refer to Figure 1.) Verify presence and condition of 0511080-1 Insulator attached to Doorpost Maplight Switch as shown.
 - (1) If 0511080-1 Insulator is not installed or if it is damaged in any way, install a new 0511080-1 Insulator as follows:

- a. Loosen screws and nut enough to slip the slotted ends of the insulator under the switch assembly.
 - b. Secure switch assembly and insulator to shield assembly with screws and nuts. Proceed to step B. (3).

- (2) If the 0511080-1 Insulator is installed and in good condition, proceed to step B. (3).
 - (3) If fuel lined is damaged in any way, replace fuel line.
