Wing Spar Inspection, 7, 8, and 11 Series

Version 1.02 07/29/1999

HOW TO INSPECT YOUR WOOD SPAR

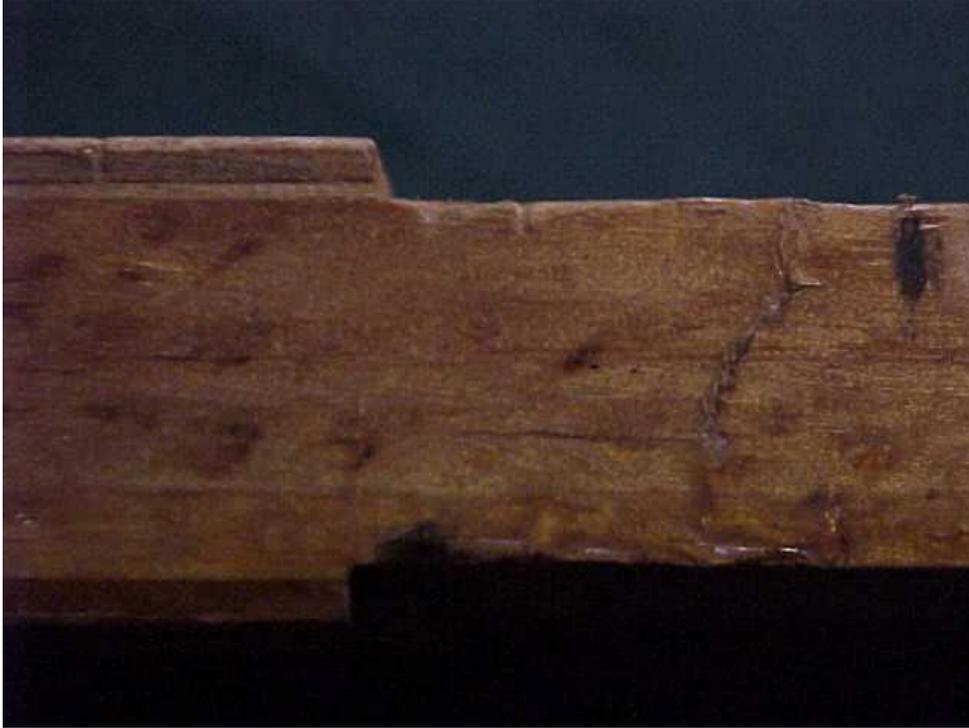
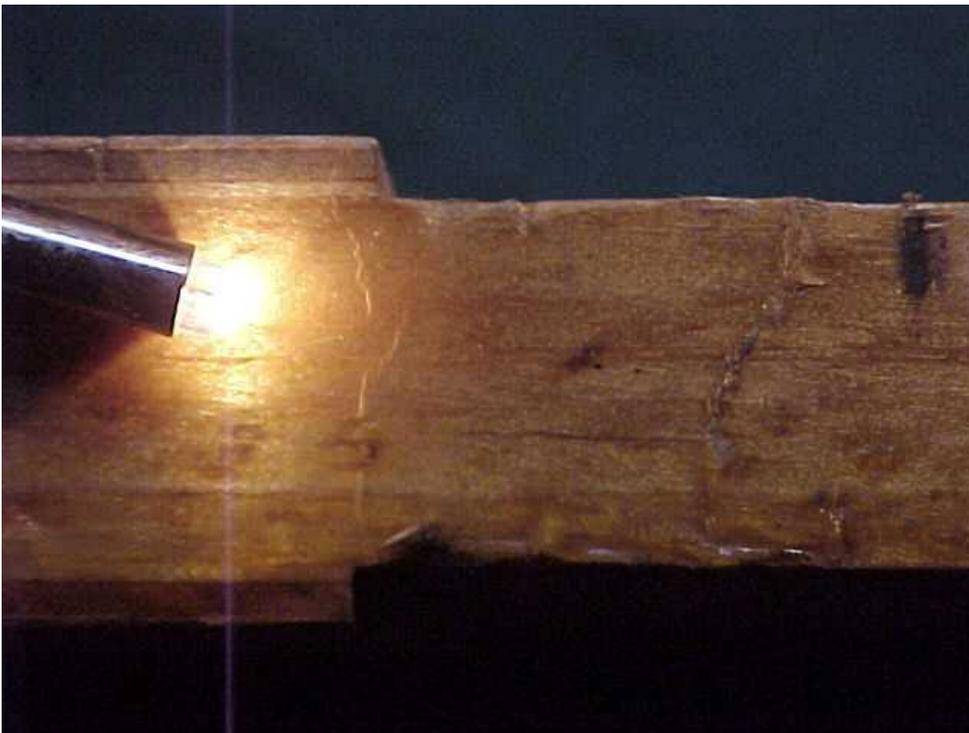
- b) Please review the following photographs. Both photos are of the top surface of the same section of spar. The first photo utilizes ambient light only. Note that a severe compression crack is visible. In the second please notice that a second, very fine, crack becomes apparent.
- i) The bright light passing through the second crack at an angle different from the viewing angle makes the crack become apparent. The light source **must not** apply light to the surface from the direction of view.

- d) NOTE: Compression cracks typically have a **jagged** or broken "chainlink" appearance and in the early stages of growth they may be limited to the top surface. Older compression cracks travel down the spar side face and may be found to turn toward a strut attach bolt hole (spar tensile strength may be reduced by 2/3s). Discovery of an anomaly that is straight is likely to be a scratch from assembly of the ribs to the spar or a glue line. If you are unable to determine if an anomaly is actually a compression crack get a second opinion before disassembling the wing.

- a) 5.1 Upon the discovery of a compression crack upon any spar, repair the wing in accordance with the latest revision of AC 43-13. In most cases repair of the wing will entail replacement of the spar(s) which have compression cracks.
- b) Please note that disassembly of the wing, replacement of defective parts, and re-assembly is a repair and NOT a rebuild per FAA terminology and may be performed in accordance with AC 43-13.
