ANATOMY OF A VALVE FAILURE

Burned exhaust valves have long been a leading cause of cylinder failures and power loss in piston aircraft engines. Modern borescopes allow us to look deep inside cylinders—and this guide will help you interpret what you see through the viewfinder.

OVERVIEW: Valves that fail to seat properly are subject to severe and uneven heating that can cause them to weaken and fail in predictable patterns.

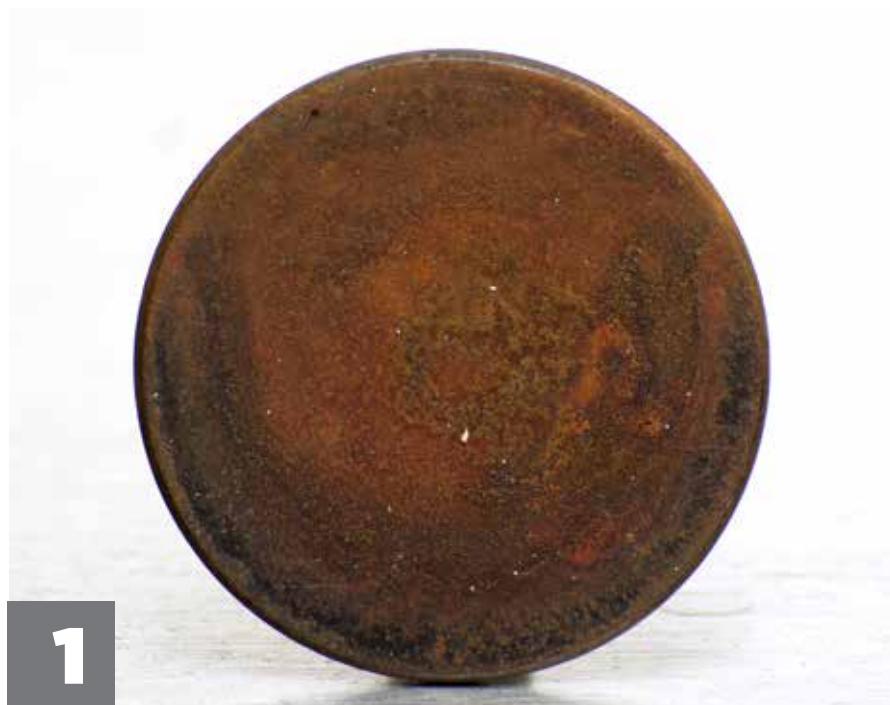
1 First indication: Circular color pattern is slightly uneven and nonsymmetrical.

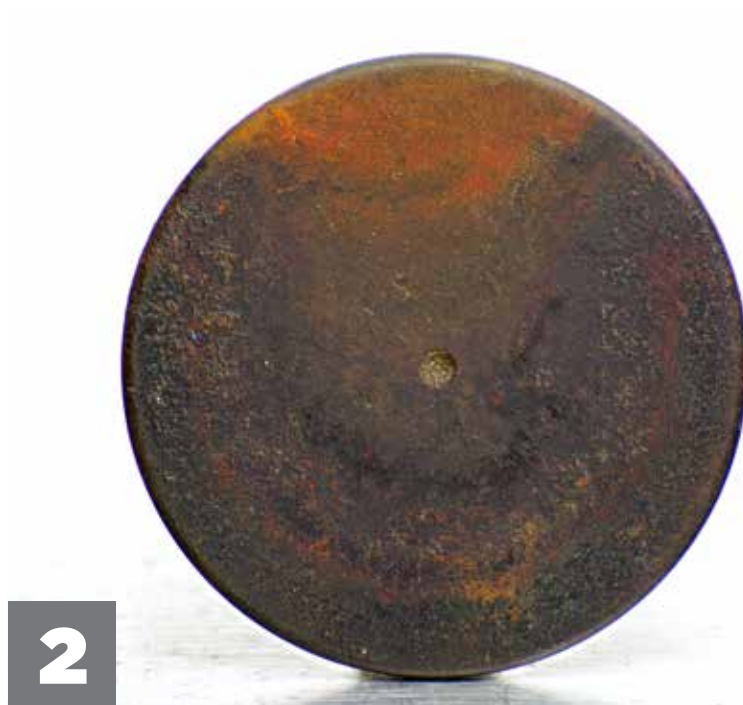
2 Crescent-shape, discolored burn pattern developing at upper edge.

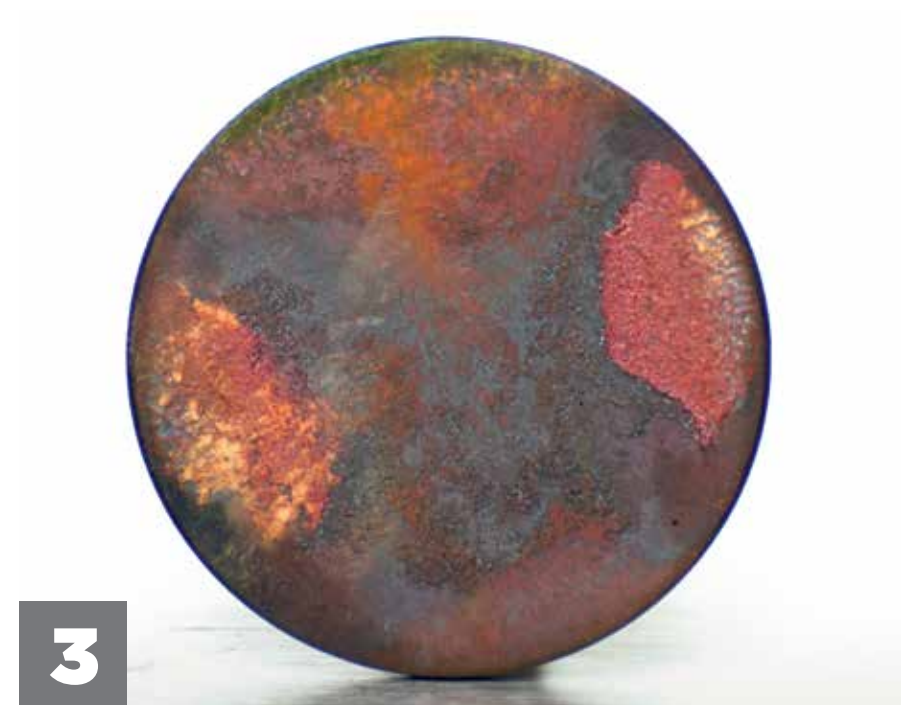
3 Burn pattern migrates inward.

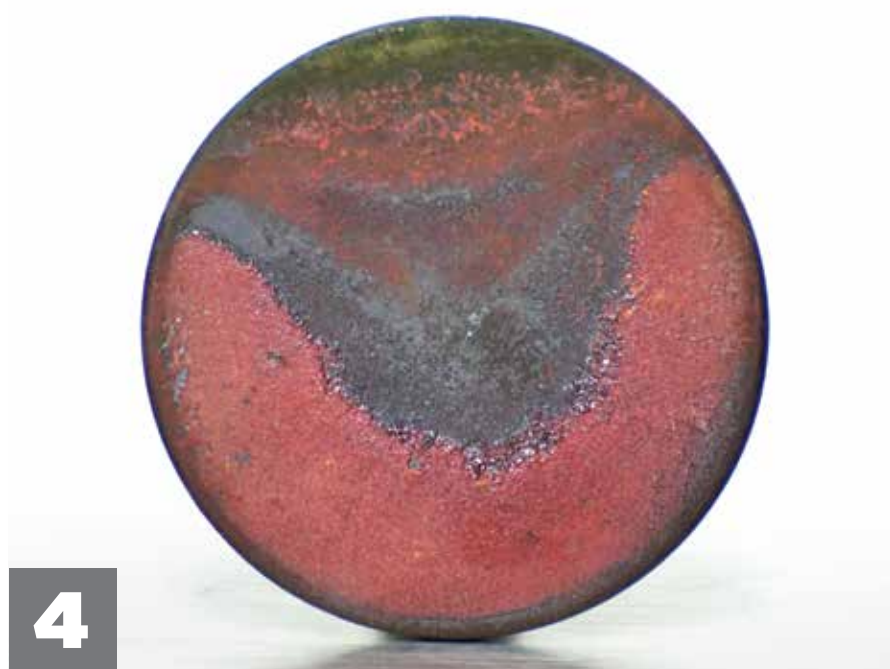
4 **GREEN MEANS STOP.** The green area at the top shows this **valve should be replaced immediately.** (Note how the uneven burn patterns match the heat distribution chart.)

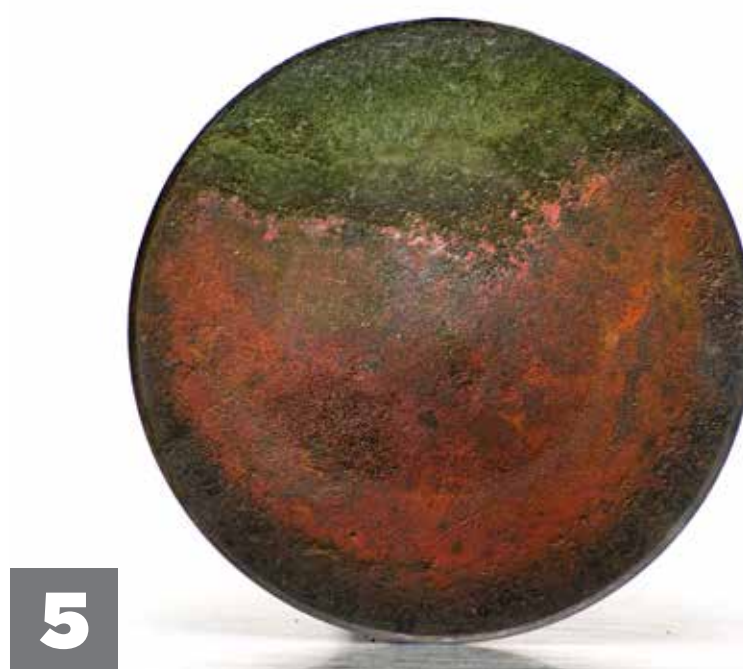
5 Green crescent progresses toward center with valve cracking and failure a serious danger.

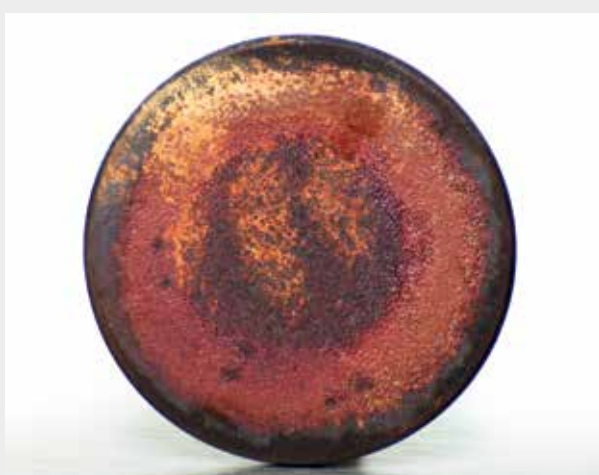
Don't be alarmed by the bright color, or deposits around the edges. The symmetrical pattern shows this valve is just fine.

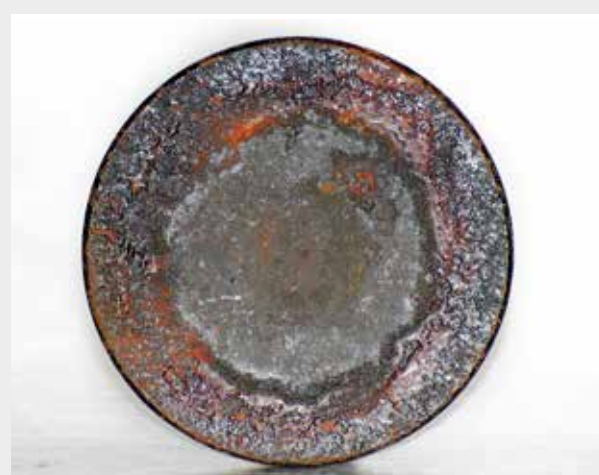
A symmetrical, circular pattern shows a healthy valve. Red and orange deposits are harmless.

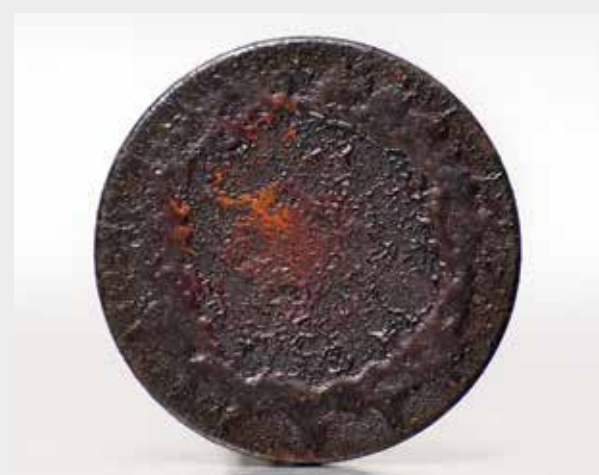
Thick lead deposits from an overly rich mixture give this healthy valve the appearance of an overcooked pizza.
