# CSB 99-6

## SUBJECT: GTSIO-520 & GIO-550 CRANKSHAFT INSPECTION

**PURPOSE:** To provide instructions for the inspection of the number two, five and eight crankshaft cheeks of GTSIO-520 style crankshafts manufactured or rebuilt in 1998.

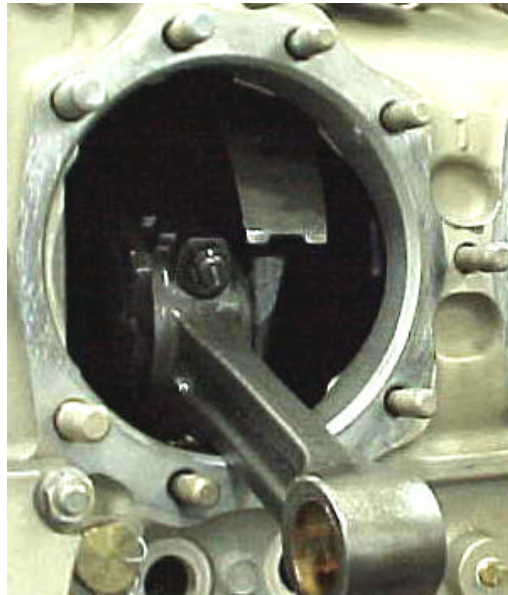
FIGURE 1  
CONNECTING ROD IN POSITION TO REMOVE COTTER PIN, NUTS AND ROD

7. Position the connecting rod to be removed (number one, three or five) at or near top center. See Figure 1.

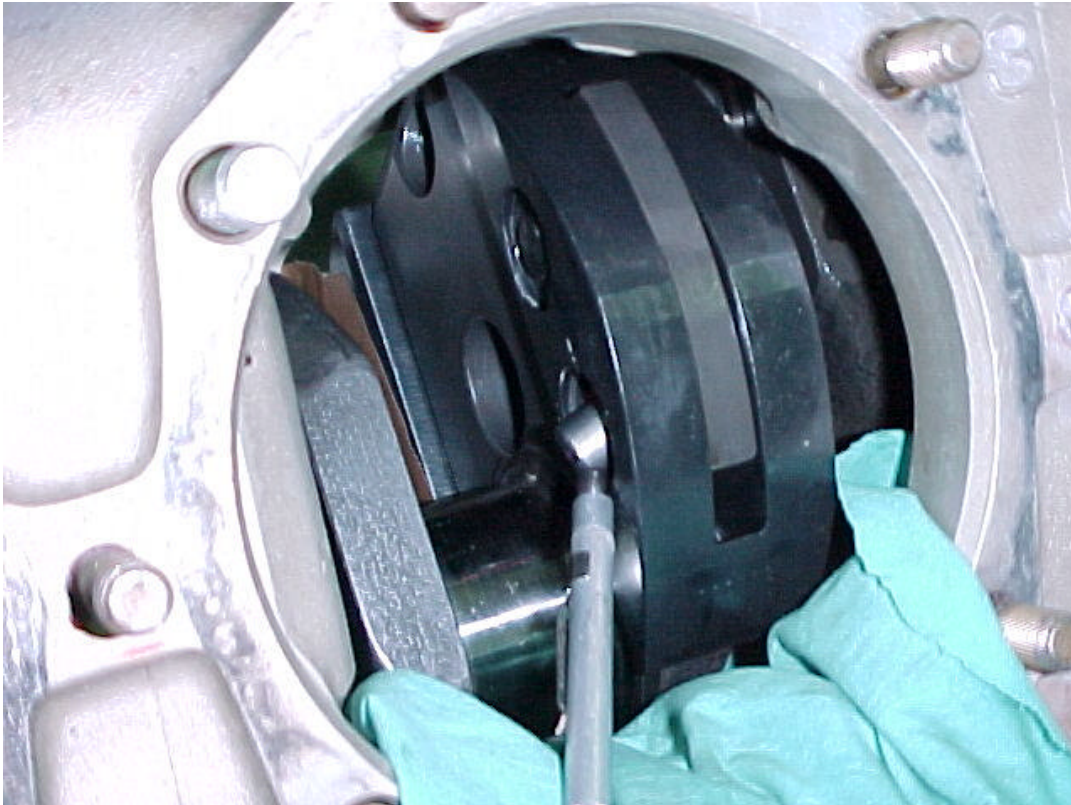
FIGURE 3  
REMOVING COUNTERWEIGHT PINS

2. Using a retrieval magnet, remove the counterweight pins on the crankshaft cheek to be inspected. Document the location of the removed counterweight pins. They must be reinstalled in the location from which they were removed. See Figure 3.

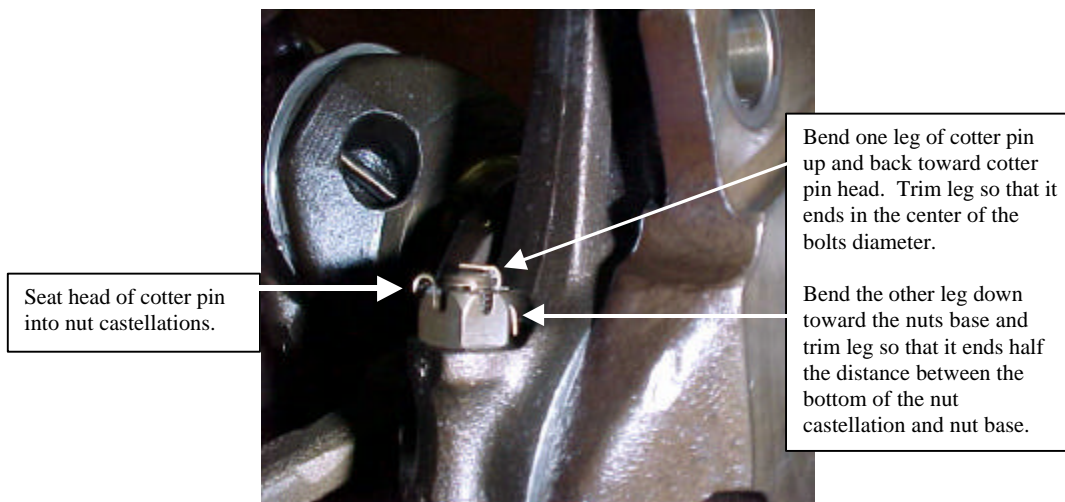
FIGURE 6

COTTER PIN INSTALLTION

10. Install new cotter pin in each nut and secure by seating the cotter pin head in nut castellations and bending one leg of the cotter pin up over the con-rod bolt and back toward the head of the cotter pin. Trim leg so that its end is centered with the center of the bolt diameter. Bend the other leg down and trim it so that its end is mid way between the nut base and the nut castellation. See Figure 6

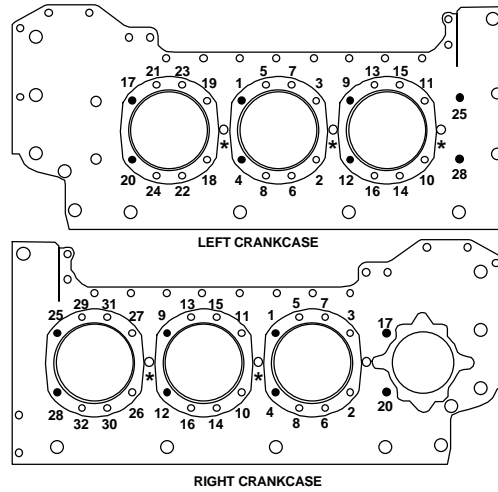
CYLINDER STUD NUT AND THROUGH BOLT NUT TORQUE SEQUENCE

- DESIGNATES CRANKCASE CYLINDER HOLD DOWN THROUGH BOLTS. ALL CYLINDER BASE STUD THREADS AND NUTS AND ALL THROUGH BOLT THREADS & NUTS MUST BE LUBRICATED WITH CLEAN 50 WT AVIATION OIL AND TORQUED TO THE SPECIFIED VALUE IN TABLE 2.
- \* TORQUE 7TH STUD NUT LAST
