Wing Spar Inspection, 7, 8, and 11 Series

Version 1.02 07/29/1999

HOW TO INSPECT YOUR WOOD SPAR

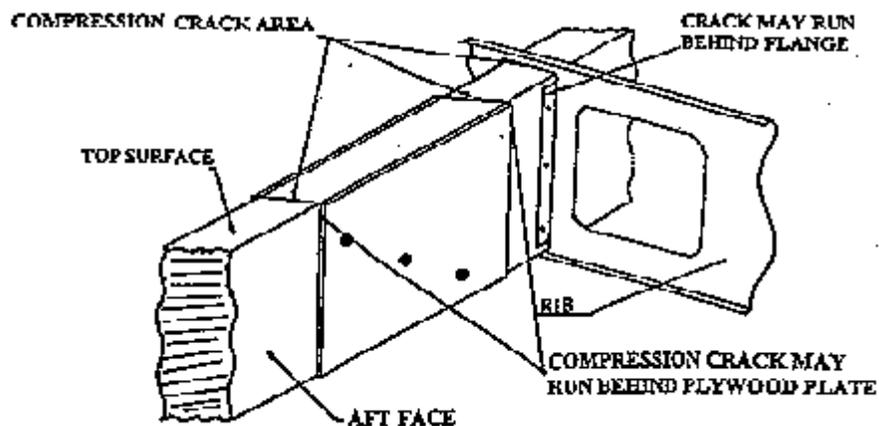
- a) Compression cracks can occur along the entire length of the spar. Information to date has shown that compression cracks occurring inboard and/or outboard of the strut-attach-bay will be accompanied by cracks in the strut attach bay itself. Please refer to the latest version of Service Letter 406 for information regarding inspection of the spars for longitudinal and butt cracks.
