National Transportation Safety Board

Safety Recommendation

In reply refer to: A-01-6 through -8

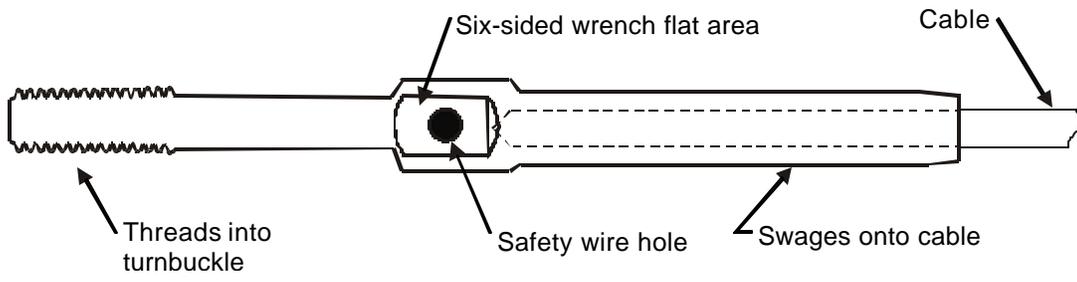
Figure 1. An MS21260-S4 terminal, drawn larger than actual size.

² Military Standard MS21260, "Terminal, Wire Rope, Stud," specifies the sizes, thread directions, and materials that are allowed in the manufacture of the terminals in question. The terminals are constructed such that one end of the terminal can be swaged onto the end of a wire rope cable. The other end of the terminal contains threads that are inserted into a turnbuckle to the depth necessary to attain the proper cable tension. The middle portion of the terminal contains wrench flats and a safety wire hole.
