TELEDYNE CONTINENTAL ® AIRCRAFT ENGINE

MANDATORY SERVICE BULLETIN

MSB 00-5
TECHNICAL PORTIONS
FAA APPROVED

SUBJECT: CRANKSHAFT MATERIAL INSPECTION

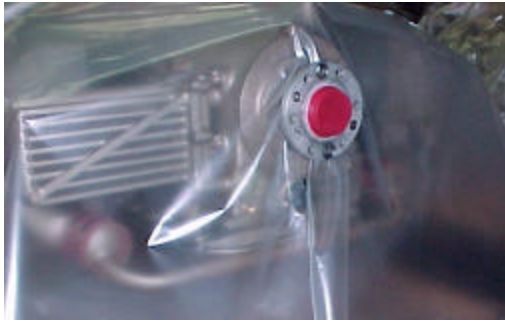
FIGURE 1
PROTECTIVE PLASTIC COVER

the lower part in such a manner that the plastic protects the lower portion of the engine and the nacelle area.

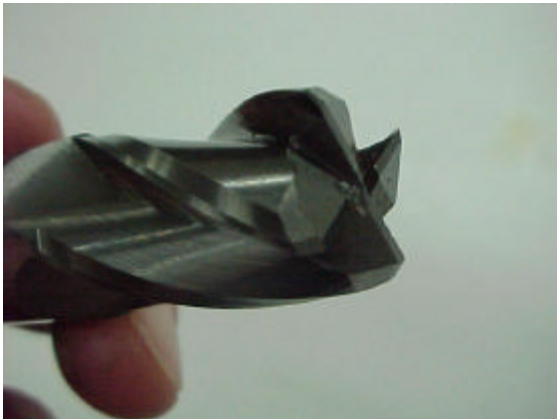
FIGURE 4
END MILL FOR SPOT FACING
PROPELLER FLANGE FRONT FACE

1. With the boring tool and adapter plate correctly positioned and mounted, install the end mill provided with the tool kit into the boring chuck. Insure that the flats machined on the shank of the end mill align with the allen set screw in the chuck. Tighten the set screws with the allen

wrench provided in the tool kit. See FIGURES 4 and 5.

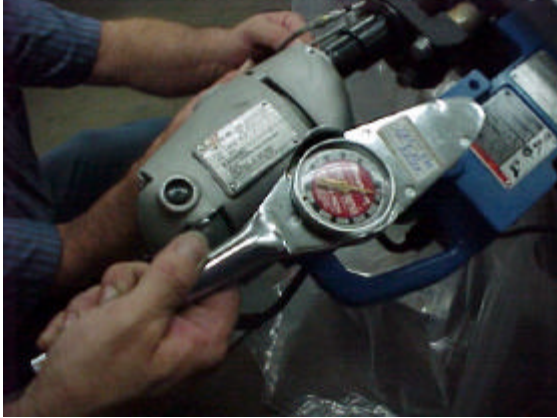
FIGURE 7
USING TORQUE WRENCH TO MAINTAIN
CONSISTENT FEED RATE

7. Turn the boring tool on using the switch provided on the tool.
8. Slowly advance the end mill toward the front face of the crankshaft flange by applying pressure to the handle of the dial type torque wrench.
9. Spray generous amounts of coolant/lubrication (LPS-1) onto the work and end mill during the spot facing operation.
10. Maintain a constant pressure on the torque wrench during the spot facing operation, but do not exceed 110 inch lbs. See Figure 7.

11. Spot face the front face of the propeller flange until the positive stop rod contacts the adapter plate surface. Additionally, as the nitrided surface is penetrated an audible sound change will occur and the feed rate of the end mill will increase as the end mill cuts into the non-nitrided steel.
12. Back the end mill away from the propeller flange front face and turn OFF the boring tool.
13. Loosen the thumb screw or set screw securing the positive stop rod in place and sliding the rod aft remove it from the holder.
14. Remove the end mill from the boring tool chuck. Clean the machining debris from the boring tool and adapter flange.

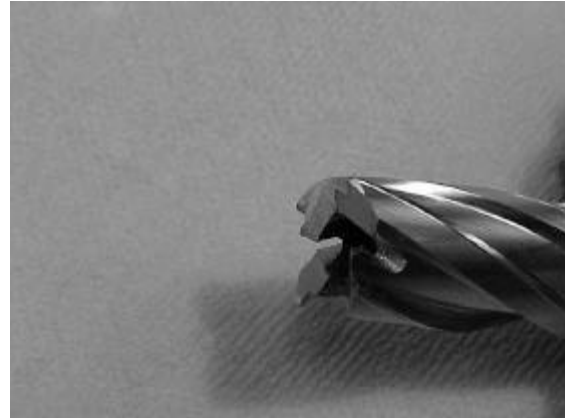
FIGURE 8
ROTOBROACH CORING BIT

1. Mount the coring rotobroach into the boring tool chuck. Ensure that the rotobroach is positioned so that a portion of the set screw flat protrudes from the end of the chuck. Secure the rotobroach by tightening the allen set screw in the chuck. See FIGURE 5 and 8.

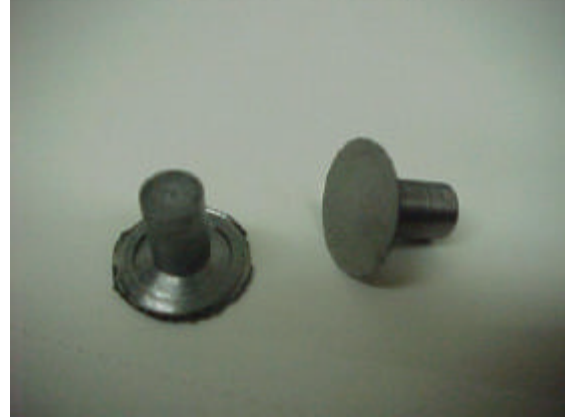
FIGURE 10

6. Once the rotobroach has cut through the back wall of the propeller flange, release the pressure on the torque wrench and pull the rotobroach out of the machined hole in the propeller flange and clear of the boring tool adapter plate.
7. Loosen the allen set screw and remove the rotobroach and propeller flange core sample from the boring tool chuck.
8. Remove the core sample from the rotobroach and place it in the self sealing plastic bag provided. See Figure 10.
9. Fill out the label on the front of the self-sealing plastic bag in its entirety.
10. Supporting the boring tool and propeller flange adapter plate loosen and remove the two nuts on the aft side of the propeller flange that secured the boring tool and adapter plate to the propeller flange.
11. Remove the boring tool and adapter plate from the propeller flange.

**PROPELLER FLANGE CORE SAMPLES
(One crankshaft set (2) per sample bag)**

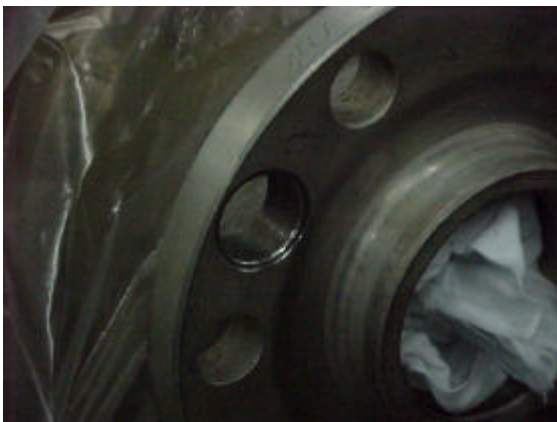
FIGURE 12
CORE SAMPLE HOLE
AFTER CHAMFERING

7. Visually inspect core sample holes for sharp edges and burrs. Remove any sharp edges or burrs prior to proceeding. See Figure 12.

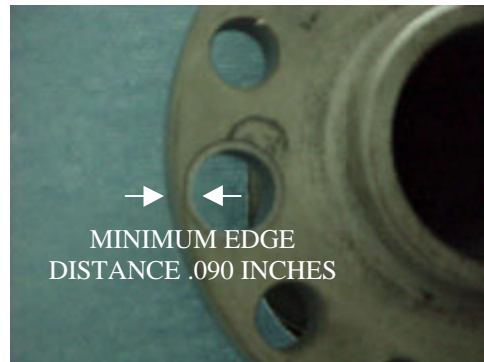
FIGURE 13
CORE SAMPLE HOLE MINIMUM
EDGE DISTANCE

4. Using 180 crocus cloth or emery paper polish the core sample hole I.D.
5. Clean the core sample holes and propeller flange using a lint free shop towel dampened with Acetone.
6. Measure edge distance of core sample hole to propeller flange O.D. Minimum edge distance is .090 inches. If edge distance is less than .090 inches, contact TCM at 1-888-200-7565.

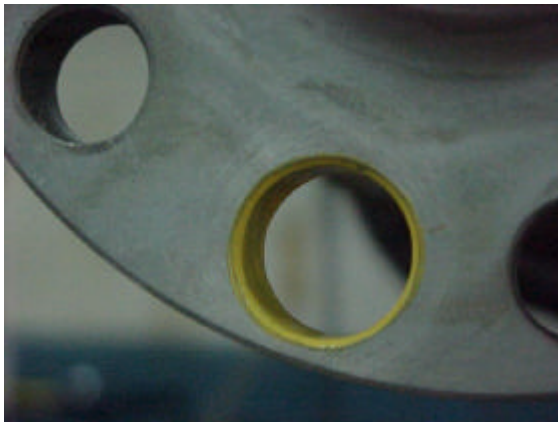
FIGURE 14
CORE SAMPLE HOLE AFTER
APPLICATION OF ZINC CHROMATE
PRIMER

1. Clean all dye check residue from the core sample holes and surrounding area with penetrant remover or acetone.
2. Using an acid brush or cotton swab, apply zinc chromate primer to core sample holes and chamfered areas on the front and aft faces of propeller flange. Allow the primer to cure completely prior to installation of the propeller. See Figure 14.
