PADE

Deering
Deering, AK

2.00 mi SW of city N66 4.1467' W162 46.0233' Mag Var: 11E

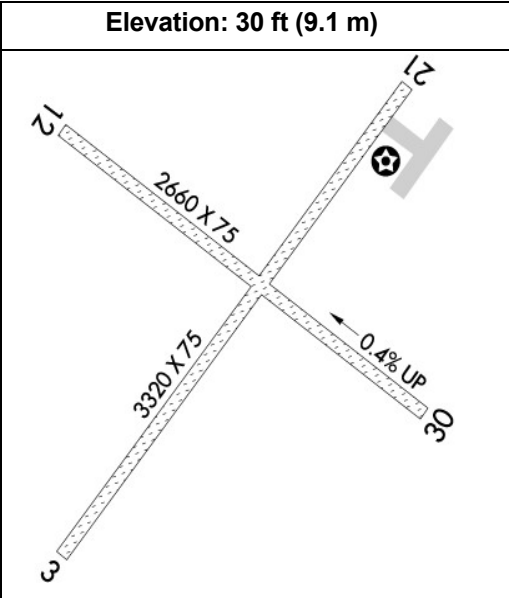
Name:	Dimensions:	Material:	Condition:	Treatment:
03/21	3320X75	gravel	good	no treatment
12/30	2660X75	gravel	good	no treatment
