PAFM

Ambler
Ambler, AK

1.00 mi N of city N67 6.3720' W157 51.4293' Mag Var: 13E

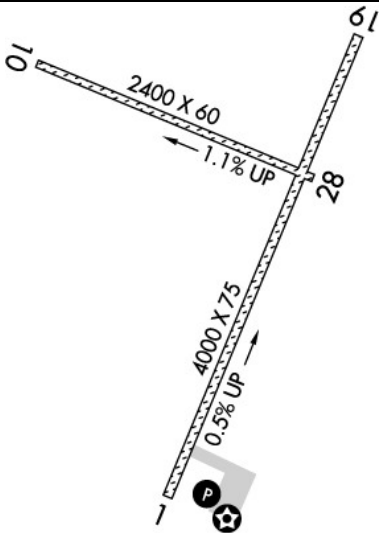
Runways:	Name:	Dimensions:	Material:	Condition:	Treatment:
	01/19	4000X75	gravel	good	no treatment
	Trees; 315' from end; 140' Right of center; 10' high; 31:1 clearance slope;				
	Trees; 0' from end; 180' Right of center; 13' high; 0:1 clearance slope;				
	10/28	2400X60	gravel	good	no treatment
